F/V St. Joseph

Vessel Overview

Incident: Weather and mechanical issues required the crew to abandon the vessel and leave it adrift.

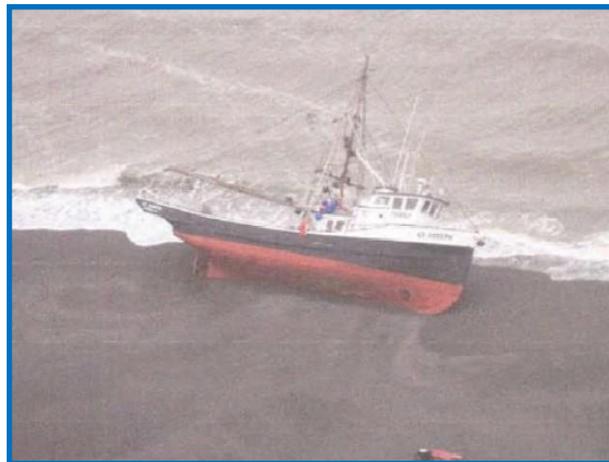
General description of location: The vessel grounded adjacent to a steep cut bank on a sandy beach which was exposed to heavy swell and breaking waves.

Vessel Disposal Process/Issues: Wave action against the vessel was rapidly damaging the vessel and piling up sand against the hull which made removing all of the vessel impossible. The bottom of the hull, propeller shaft, cement ballast and keel could not be removed and were left on the beach.

Removal Methods: The St. Joseph was cut apart and disassembled on the beach by the salvage contractor, who burned anything burnable on location and hauled all un-burnable materials to a staging area for removal by aircraft.
