NOAA Abandoned and Derelict Vessel Case Study

S/V Velero

Contributor: Clifford Inn, Hawai'i Department of Land and Natural Resources

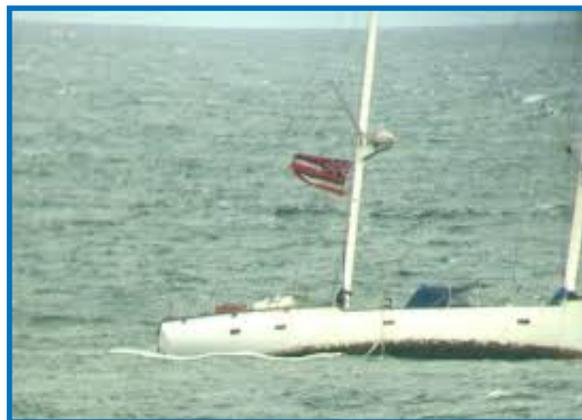
History: The sailing vessel Velero was found grounded on a coral reef roughly a mile offshore of Kalepolepo, Maui. The vessel was lying on its port-side in about 3 feet of water. After being informed of the abandoned vessel and its location Hawai'i's Department of Land and Natural Resources immediately solicited a bid from marine salvage contractors for the removal and disposal of the vessel. Because of the abandoned vessels remote location and the special equipment required to patch or dismantle a cement hull vessel the bids that were received were all above \$250,000 which was considered a prohibitive amount by the state for the removal of a single vessel. Before any further decision could be made and removal efforts started the hull collapsed and the vessel sank below the surface. Because no pollution or marine debris was spotted near the area where the vessel sank, no further action to date has been taken by the state to remove this vessel.

Environmental: The spread of marine debris, pollution from fuel and oil, and additional coral damage were the primary environmental threats identified. A Coast Guard contractor removed 80 gallons of diesel fuel prior to the vessel sinking.

Removal options considered: The removal method that was considered involved patching the vessel on the reef, pumping out the water and refloating the vessel. Because of possible damage to the reef corals it was recommended that the salvage crew remove the vessel from the seaward side of the reef and float the vessel in a way that would allow it to remain on its side in order to minimize the chance of the keel or the hull touching the reef and coral as it is being towed seaward and off-shore.
