Removing Sunken Vessels in Oregon

Vessel Overview

Name: F/V Ina and Lovechild

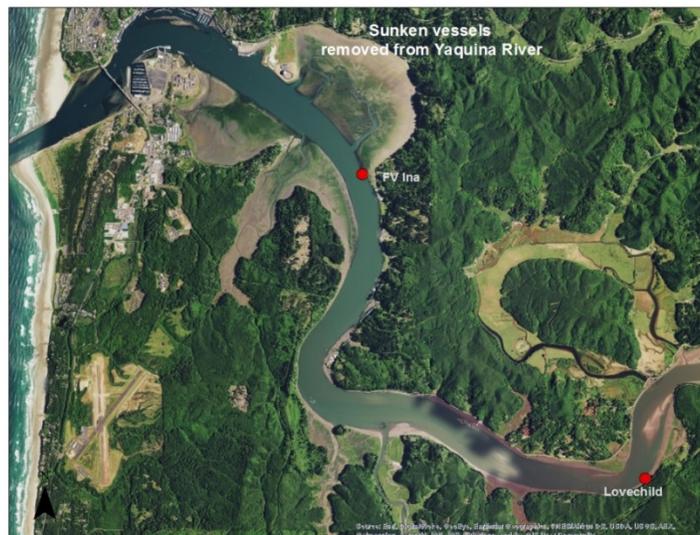
Location: Both vessels sank in the Yaquina River, near Newport, OR, about 5 miles apart. See map right for approximate locations.

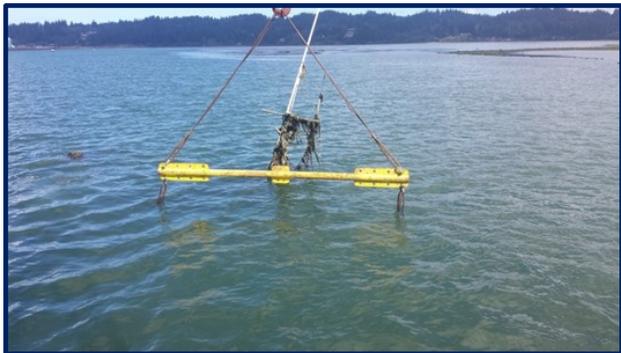
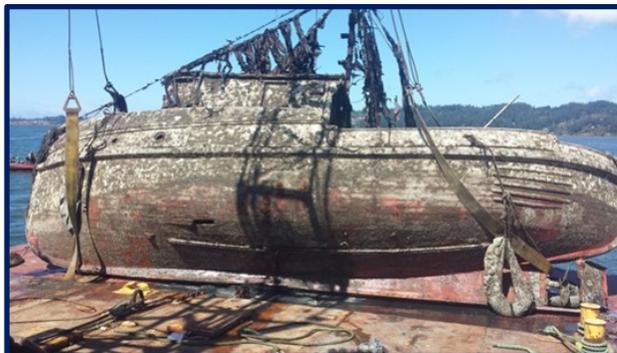
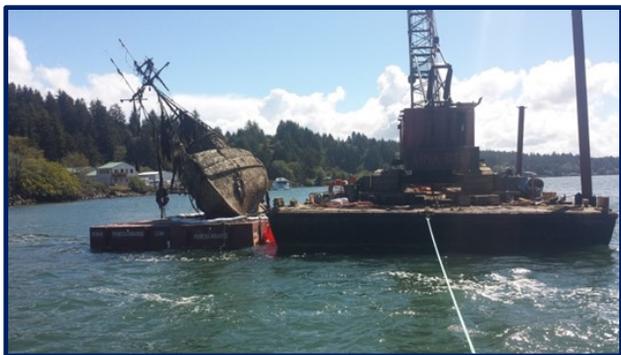
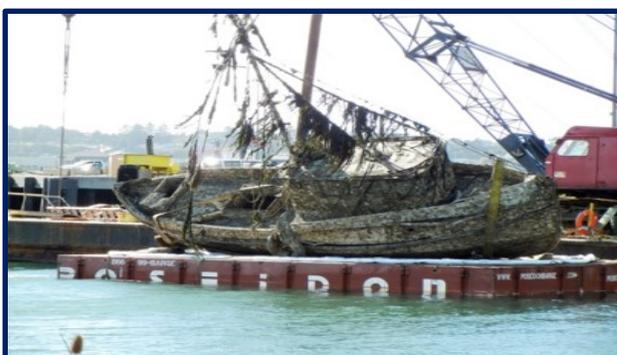
Images: first 4 photos are the FV Ina being removed; second 4 photos are the Lovechild's removal

Removal Methods: The contractor who won this bid used a crane barge to lift the vessels out of the water and on to the barge for transport to the Port of Newport, where they were demolished on land. Divers placed lifting slings around the vessels prior to being lifted out and used dewatering pumps to remove water from within the vessels. The vessels were both made primarily of wood and had been stripped of all valuable parts, so demolition was fairly straightforward.
