# NOAA Abandoned and Derelict Vessel Case Study

## S/V Kikimo

Contributor: Clifford Inn, Hawaii Department of Land and Natural Resources

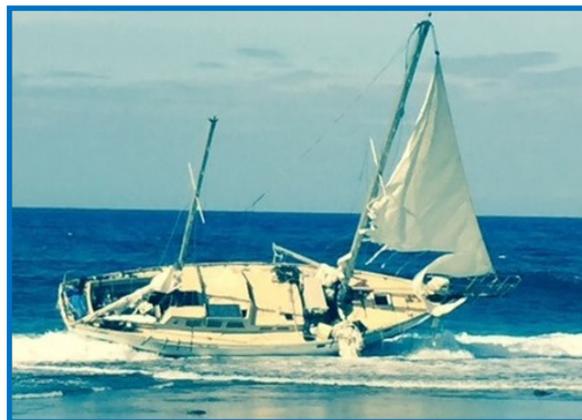
**Name:** Kikimo  
**Incident:** Vessel grounding and abandonment  
**Date reported:** 4/1/2015  
**Vessel type:** Sailboat (Ketch)  
**Vessel ID#:** HA6950G  
**Hull material:** Ferro cement construction  
**Length:** 55 feet  
**Beam:** unknown  
**Tonnage:** unknown
